Case Story

**Blue Circle
Industries PLC**

FINE FILTRATION - INDUSTRIAL GEARBOXES
AEI 3000 HP DDDR Cement Mill Gearbox

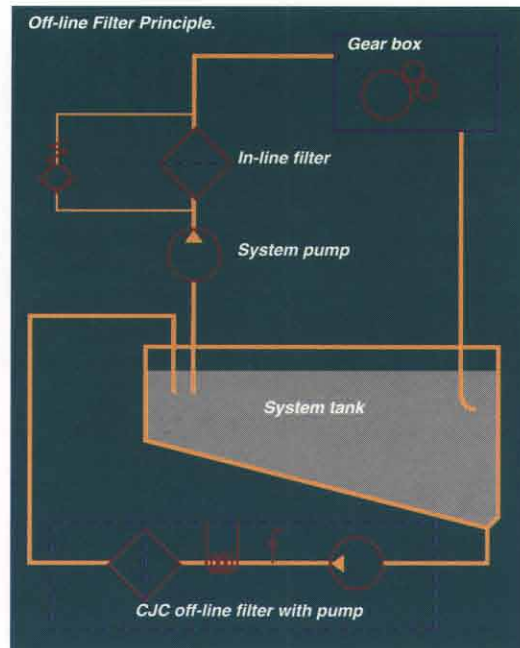
Ill. 1

HDU 27/27 B-M85 off-line unit with P360 pump (360 ltr/h), 4 kW electrical preheater, and control box. Mounted on skid plate with protective brackets. Filter suction: see ill. 1.

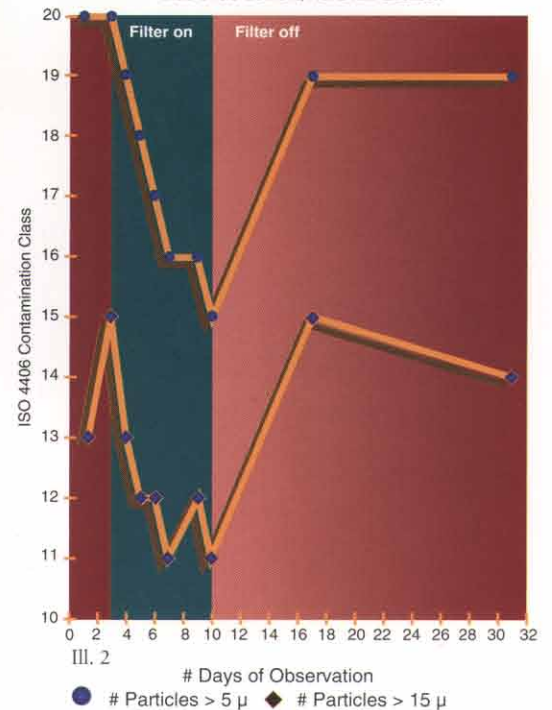
Ill. 2

The results from the Mobil EM/PA analysis reports are presented in ill. 2, using the ISO 4406 contamination classification system. The Y-axis states the ISO class (a change of one range number is a doubling or halving of the contamination, i.e. 15 is twice as dirty as 14). The first red column represents a typical prefiltration value. The first 'filter on' sample was taken immediately after the reconnection of the filter unit. The 'filter off' samples were taken at intervals after the week of continuous (round-the-clock) filtration.

The analysis results clearly proves that a **dramatic reduction in particulated contamination** occurred during the week of filtration (from ISO 20/15 to 15/12, samples of Nov 8th and Nov 15th).

In just one week without filtration (Nov 15th to Nov 22nd) the contamination increased to a high level of 19/15 and plateaued at this level for the remainder of the study.

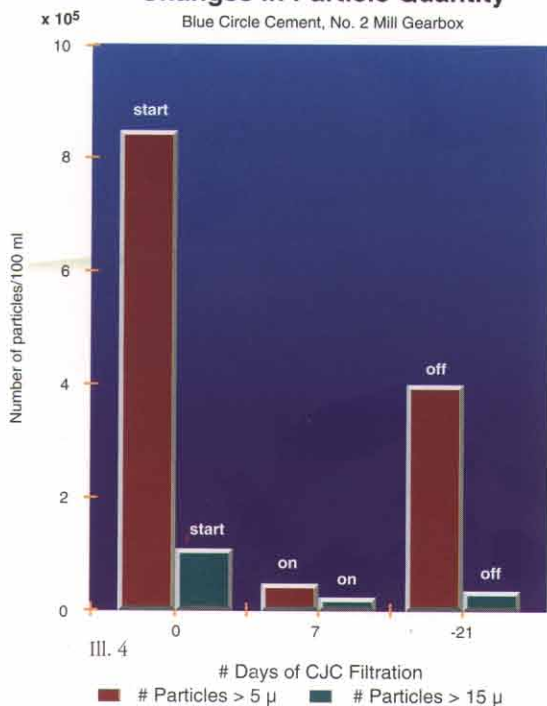
The Filtrex results (ill. 3) states the actual number of particles/100 ml oil that corresponds to the given ISO Class Codes. Note the significant drop and following rise in water content.

Filtrex Services, Particle Analysis			
Sample date:	08.11	15.11	06.12
ISO Class >5 µ:	20	15	19
ISO Class >15 µ:	17	12	15
# particles >5 µ:	869,648	31,798	408,657
# particles >15 µ:	92,352	3,848	16,391
Water, ppm:	123,6	17,2	344,2

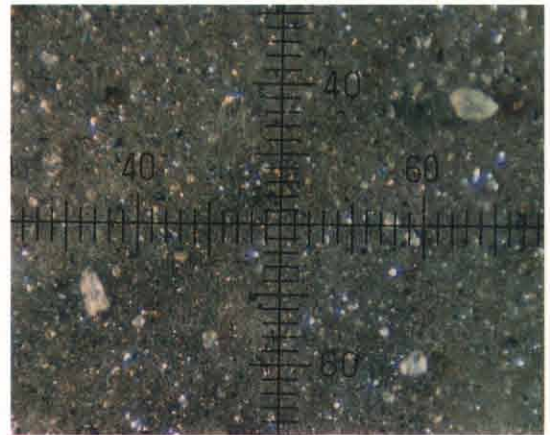
Ill. 6

Before sample, Nov 8th, before filtering. ISO 20/17.

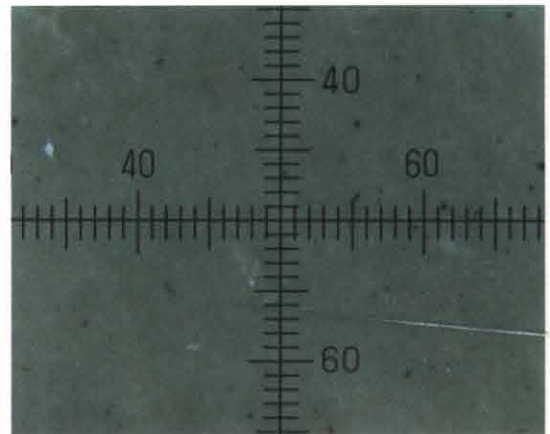
After sample, Nov 15th, after one week of filtration. ISO 15/12.
