# Lube Oil Conditioner Unit

## C.C. Jensen Oil Filter Systems

GE 7FA Gas Turbine

Calpine  
Broad River Energy Center

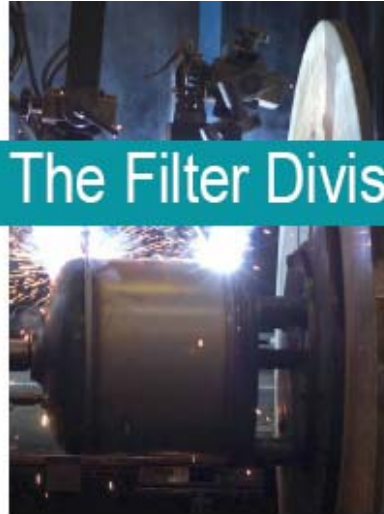
## The Filter Division

**Off-line Filtration Systems  
for Removal of  
Particles, Water, and Oxidation Deposits  
from Oil.**

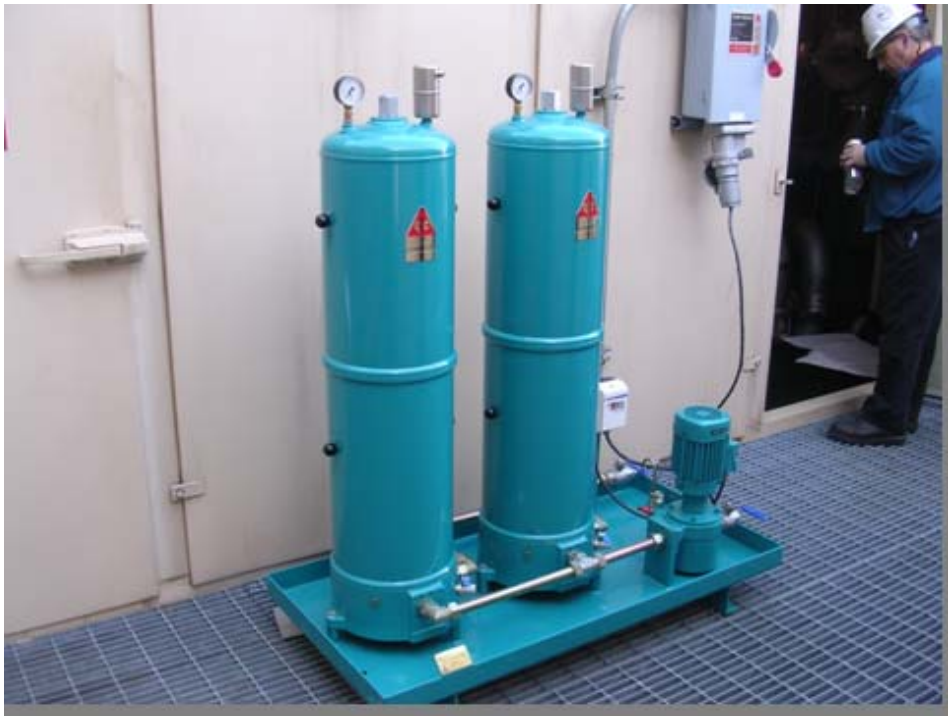
Gaffney, SC

Run Time: December 13,  
2005 to Present

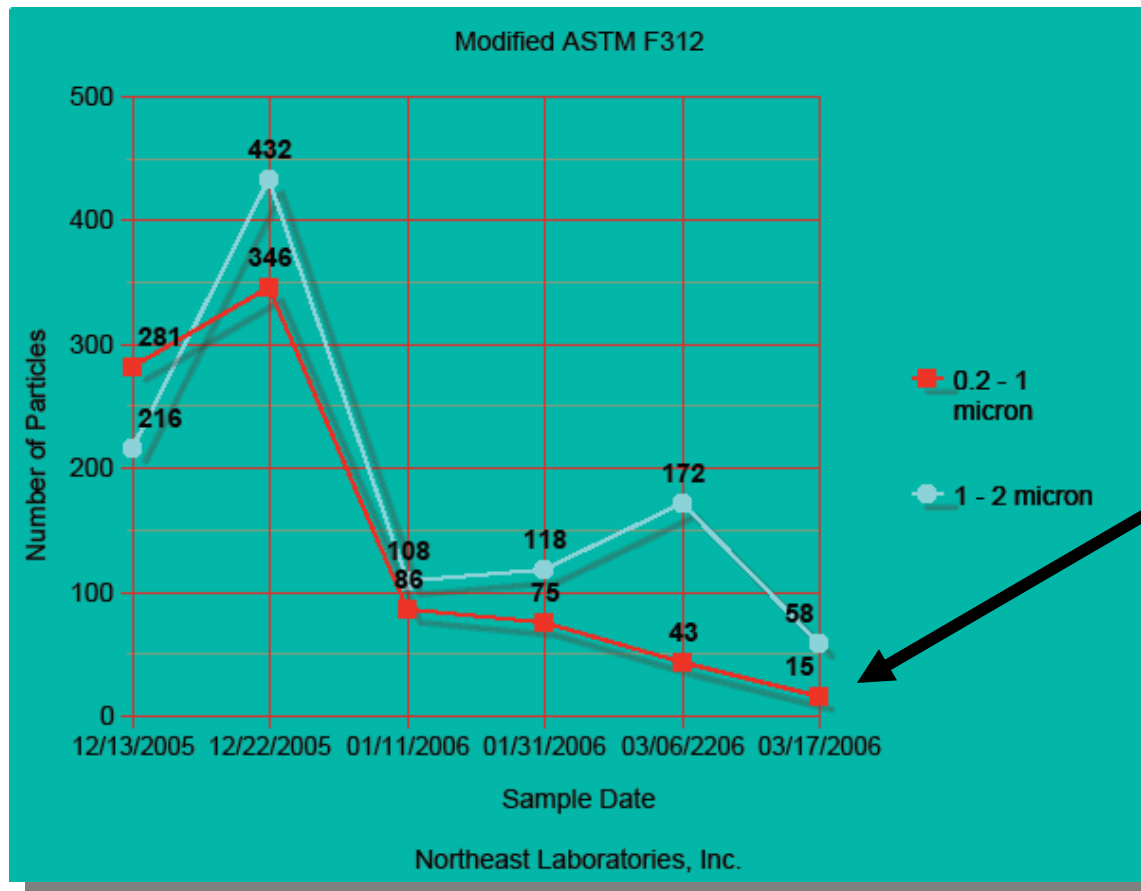
## Sub Micron Particle Count – Mod. ASTM F 312

**95%  
Reduction**

Sample Date	0.2 - 1 $\mu$	1 - 2 $\mu$	Total	% Removed	Notes
13-Dec-05	281	216	497	Baseline	Unit Hours (Total / Test): 3,781 / 0
22-Dec-05	346	432	778	-	
11-Jan-06	86	108	194	61.0%	
31-Jan-06	75	118	193	61.2%	
6-Mar-06	43	172	215	56.7%	
17-Mar-06	15	57	72	85.5%	Unit Hours (Total / Test): 3,790 / 9
1-Jun-06	2,123,610	4,260	2,127,870	-	Unit Hours (Total / Test): 3,921 / 140
13-Jun-06	2,552,080	1,756,740	4,308,820	-	1 - A 27/27 Inserts added on 12-Jun-06
23-Jun-06	130	108	238	52.1%	8 - A 27/27 Inserts added on 23-Jun-06
24-Jun-06	3,811	473	4,284	-	
30-Jun-06	43	129	172	65.4%	Unit Hours (Total / Test): 4,040 / 259

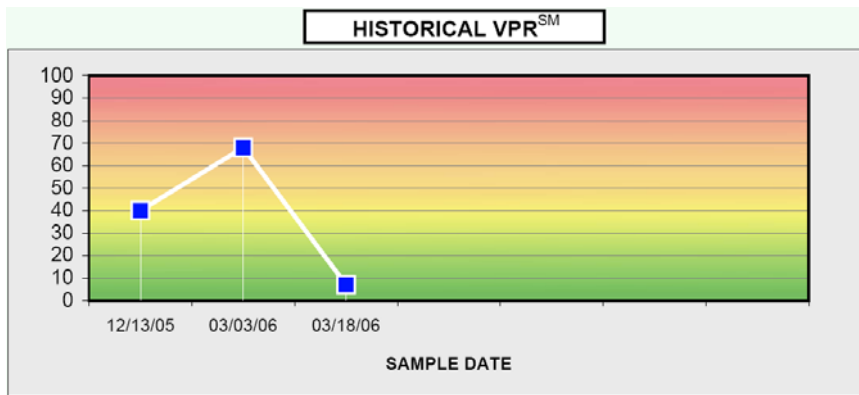
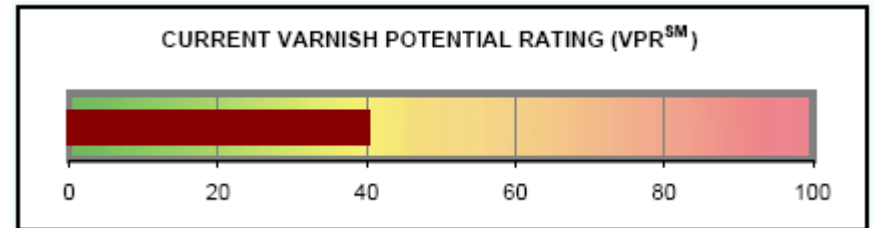
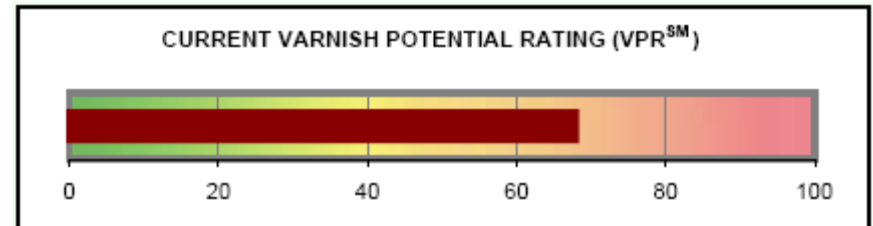
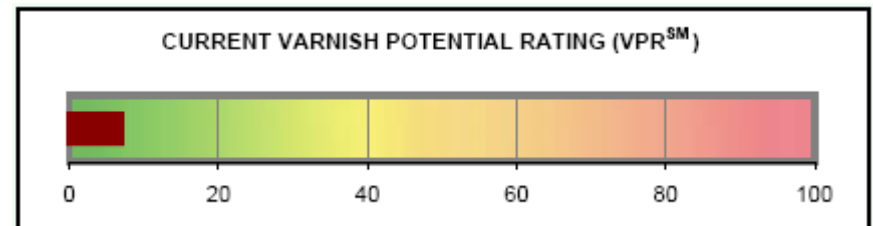
## Patch Colorimetric Test

**December 13, 2005**

**March 3, 2006**

**March 17, 2006**

Provides a quantifiable scale to trend varnish potential

Scale: 0 to 100

0 to 40 = Normal

41 to 60 = Caution

61 to 100 = Critical

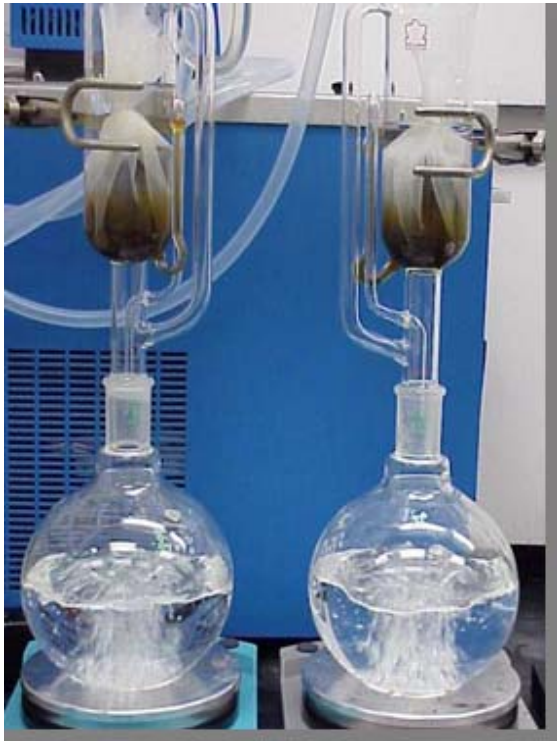
## Gravimetric Analysis – Used Filter Inserts

<b>A 27/27</b>	<b>INITIAL WEIGHT (g)</b>	<b>FINAL WEIGHT (g)</b>	<b>GAIN/LOSS</b>
Flask	372	403	31
Filter	44	12	32
<b>B 27/27</b>	<b>INITIAL WEIGHT (g)</b>	<b>FINAL WEIGHT (g)</b>	<b>GAIN/LOSS</b>
Flask	381	395	14
Filter	26	10	16
<b>Average (Filter)</b>	<b>35</b>	<b>11</b>	<b>24</b>

Ratio of Filter Mass to Varnish Mass Removed: **1:2.18**

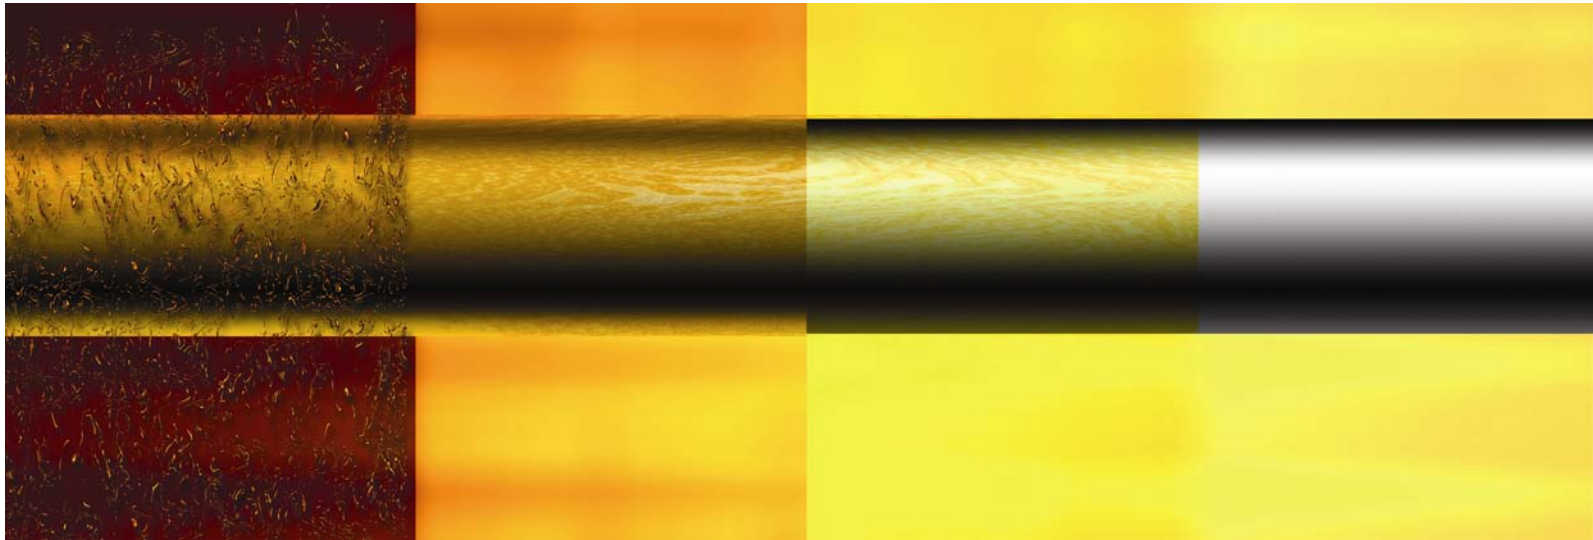
## Adsorption Equilibrium

*Removal of Varnish from Metallic Surfaces*

*Adsorption  
Phase*

*Clean Oil  
Phase*

*Desorption  
Phase*

*Maintenance  
Phase*

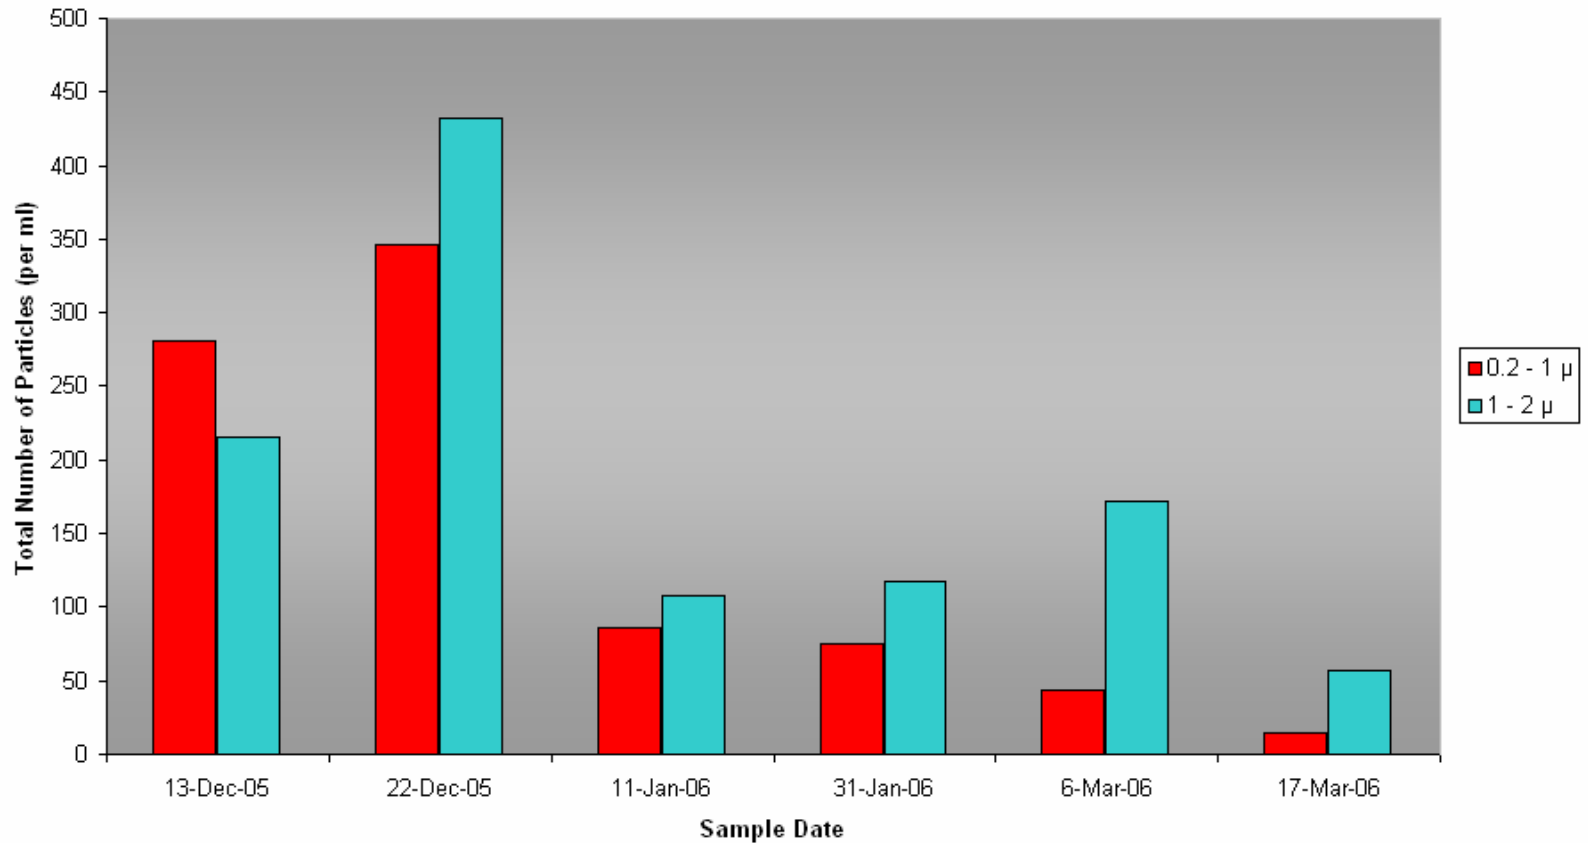
**GE 7FA Gas Turbine**  
**Turbine Status: Idle**  
Sub Micron Particle Count - Modified ASTM F312

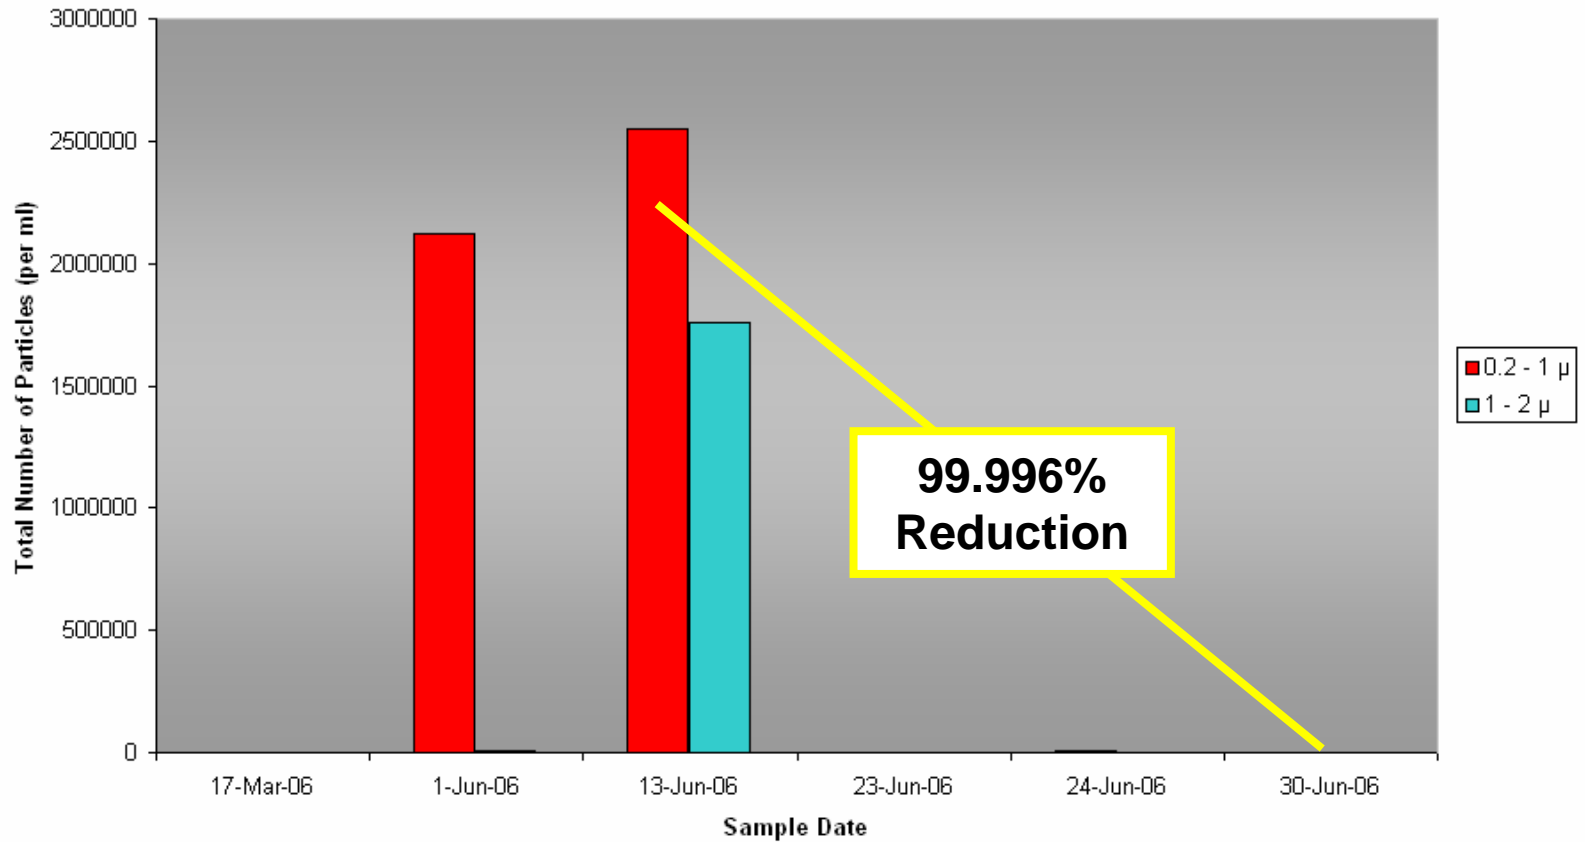
**GE 7FA Gas Turbine**  
**Turbine Status: Operative**  
Sub Micron Particle Count - Modified ASTM F312

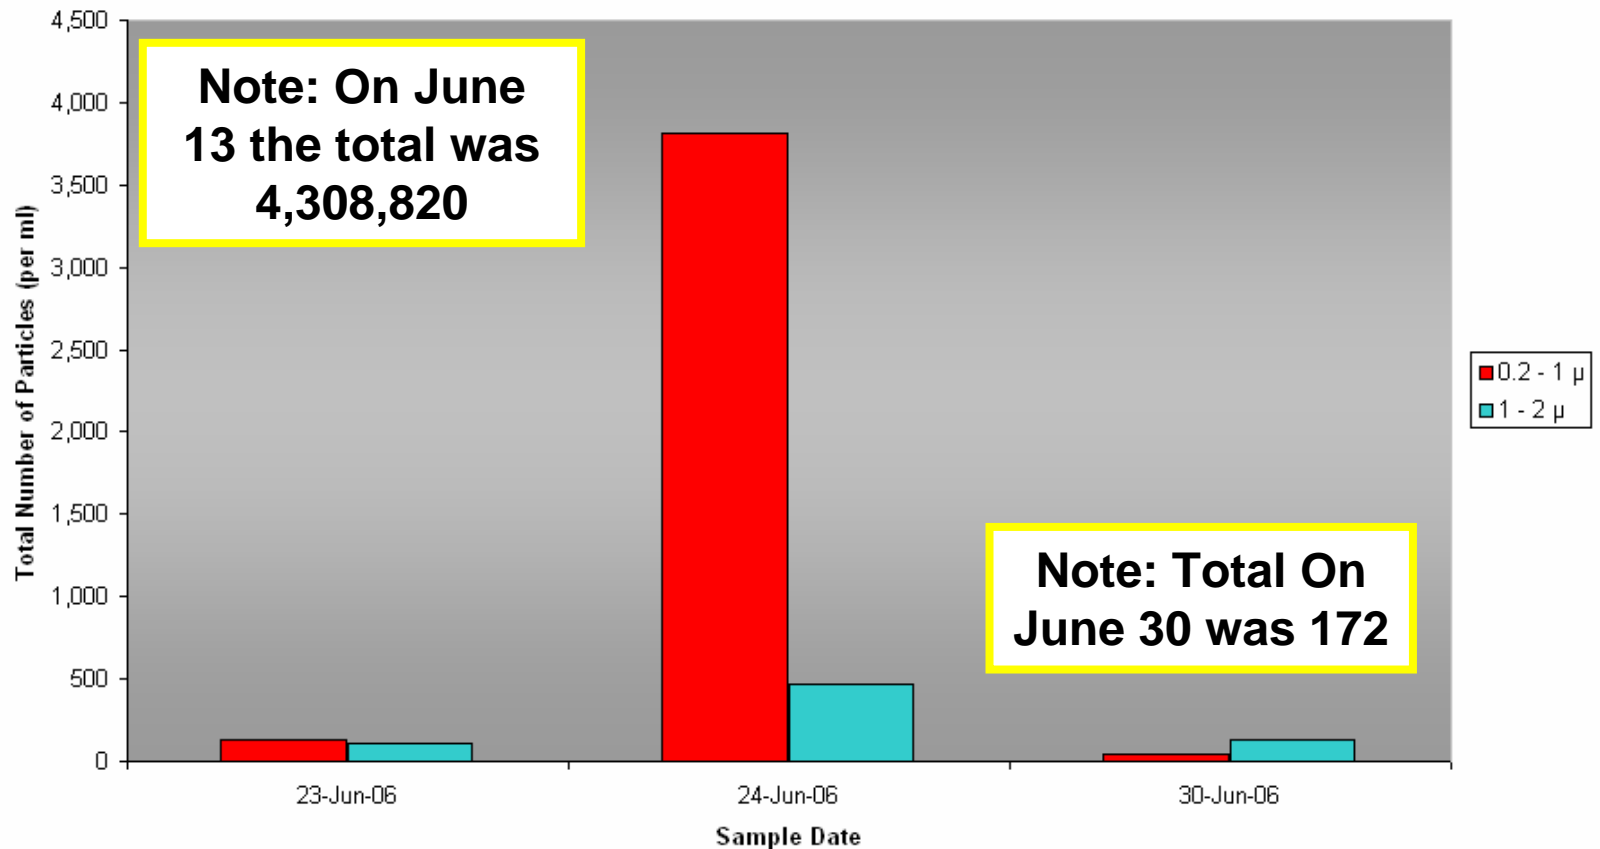
## GE 7FA Gas Turbine

**Turbine Status: Operative, After Filter Insert Replacement (22-Jun-06)**

Sub Micron Particle Count - Modified ASTM F312

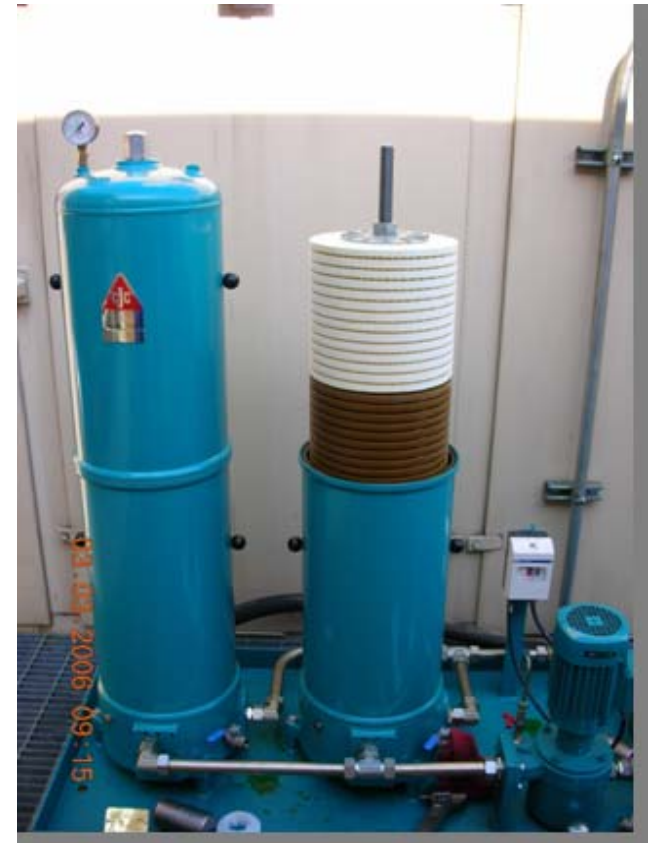
## Adsorption of Varnish in Cellulose Filter Inserts

- Most likely occurs by **physisorption**
- **Electrostatic forces** are phenomena that contributes to physisorption
- Electrostatic forces include polarization, field-dipole interactions, and especially **hydrogen bonding**

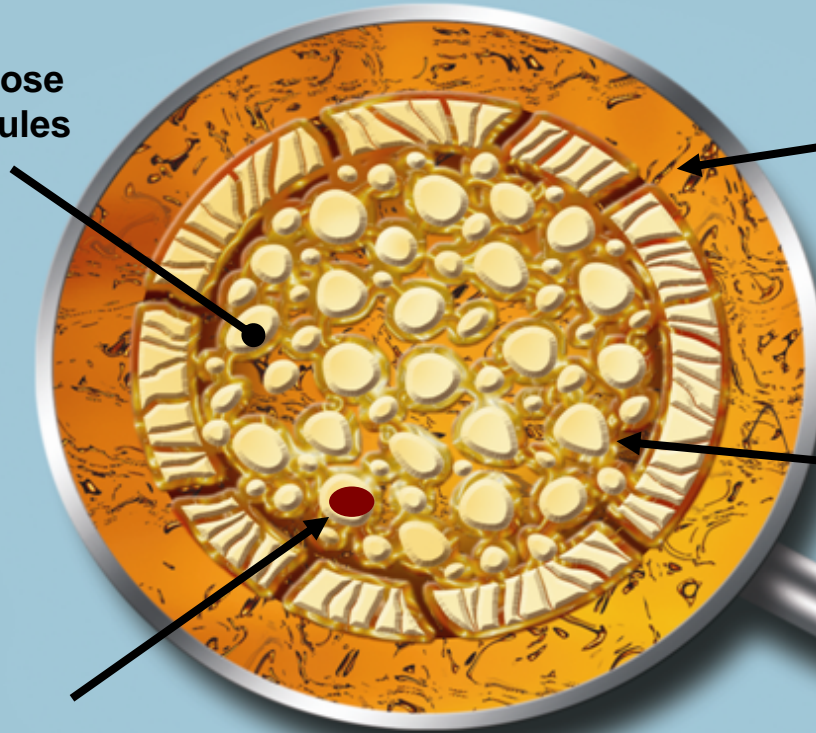
### Cross-Section of Fiber

Cellulose  
Molecules

**Step 1 "Film" Diffusion**  
Varnish particles are transported from the oil to the boundary of the fiber bundle (adsorbent)

**Step 2 Macropore Diffusion**  
Takes place within the adsorbent, among or between molecules

**Step 3 Micropore Diffusion**  
From the pore fluid to the molecules
