# CJC™ Application Study

## Lubrication Oil - Paper Machine

Norske Skogindustrier ASA,  
Saugbrugsforeningen,  
Halden, Norway.

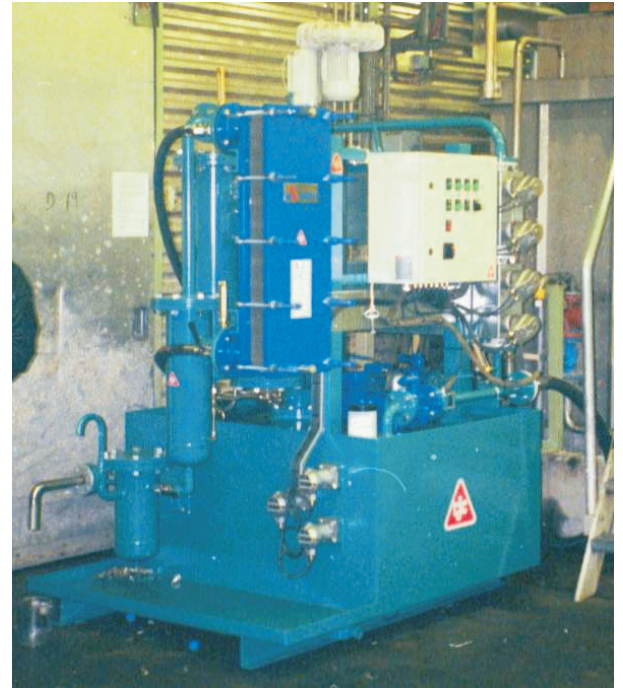
*CJC™ Desorber D38 GP-EH1T.*

For water removal a **CJC™ Desorber D38 GP-EH1T** with a **1400 ltr./h circulation pump** was installed during September 2000. The Desorber draws the oil from the return chamber and delivers the treated oil back to the suction chamber.

The Desorber has taken out an average amount of 0.5 litres of water per hour since it was installed. All visible water drops under the top of the tank have disappeared and the oil has regained its original colour and is clear.
