**C.C. JENSEN**

OIL FILTRATION SYSTEMS

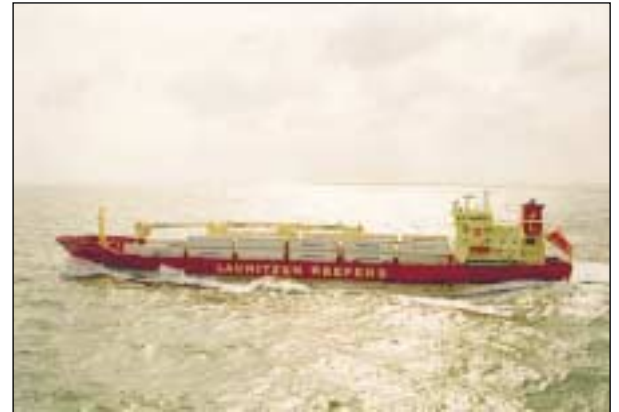
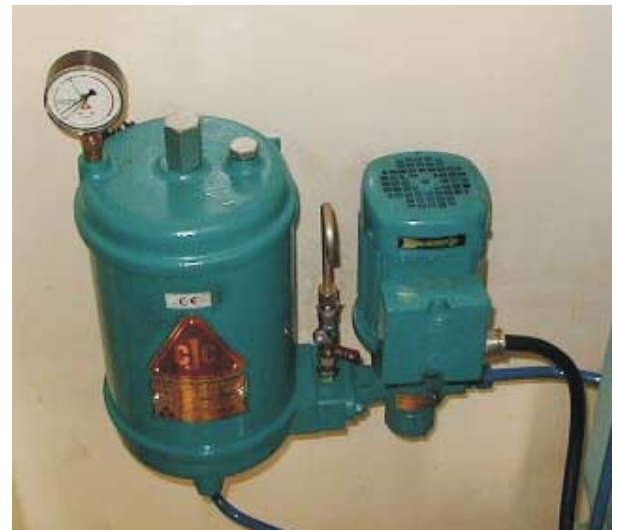
*CJC™ HDU Fine Filter type 15/25 installed on the crane of M/S Chilean Reefer.*
