Varnish Removal Unit

Solution for removal of dissolved and suspended
soft contaminants from oil in

Gas & Steam Turbines

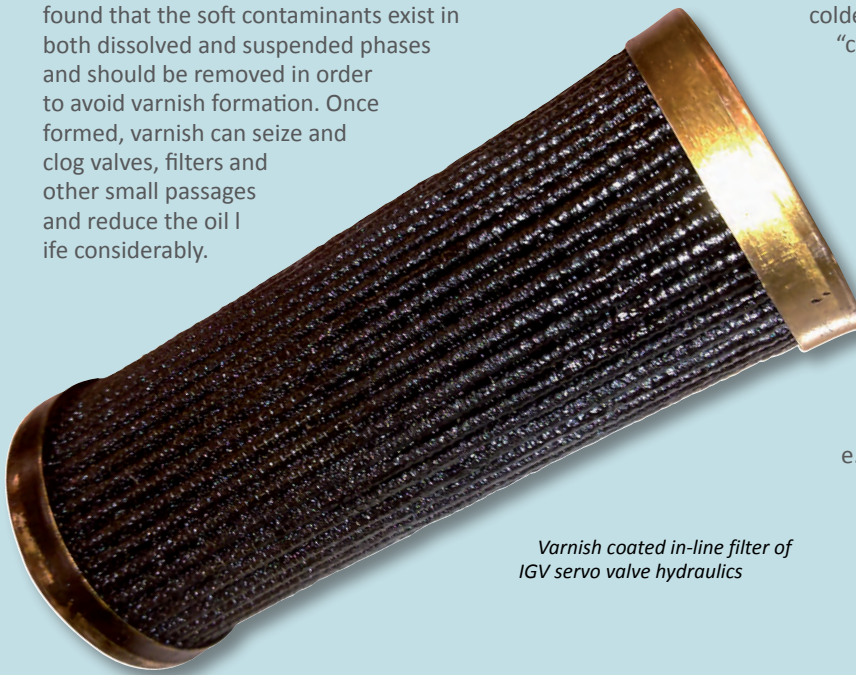
Varnish coated in-line filter of IGV servo valve hydraulics

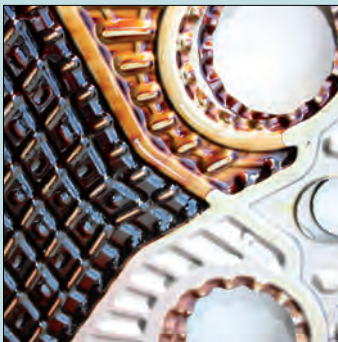
Varnish on plate heat exchanger

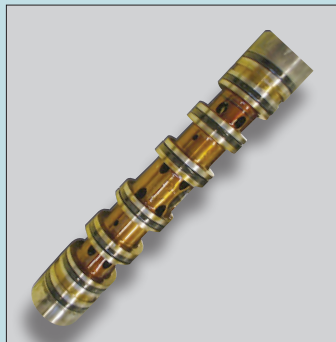
Varnish on valve spool
